# **Ashford Residential Estate, Alton**

# **Arboricultural Condition Survey**

South Downs Tree Services Limited

30 May 2024

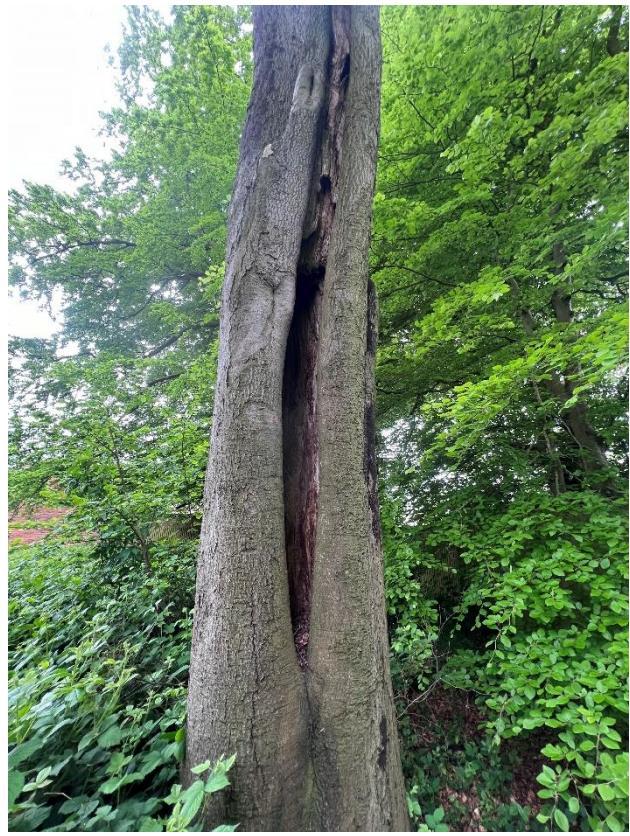
T2	<i>Fagus sylvatica (</i> Beech <i>)</i>	5	0.85	0	0	0	0	Dead	Dead	М	Dead, crown remove habitat pole at 5m. ( opening from 1m to Within falling distand residential fence line Evidence of nesting Subject to Tree Pres Order: EH983.	ed to leave Cavity 5m North. ce of e West. birds. servation	Re-inspect within 24 months to assess structural condition.

Picture showing cavity opening from 1m to 5m North on T2.

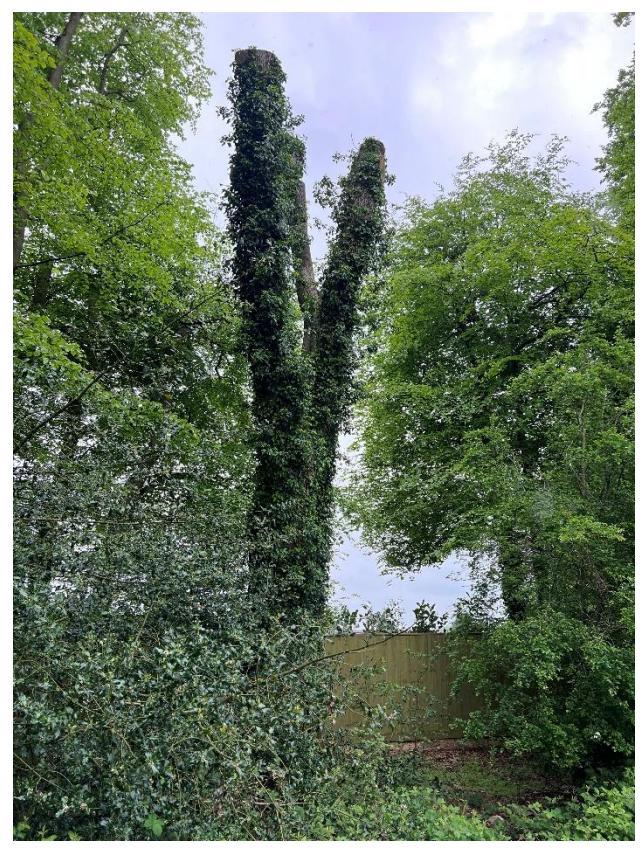
ID	Species	Heig ht (m)	Trun k dia.	Bran	Branch Spread (m)		Physiological Condition	Structural Condition	Life Stage	General observations	Preliminary Management Recommendations	
ТЗ	Fagus sylvatica (Beech)	7	(m) 1.20	0	0	0	0	Dead	Dead	Μ	Dead, crown removed to leave habitat pole at 7m. Stem bleeds scattered around trunk. Bark included union at 2m, within falling distance of residential fence line West. Subject to Tree Preservation Order: EH983.	Re-inspect within 24 months to assess structural condition.
Τ4	<i>Fagus sylvatica (</i> Beech <i>)</i>	4.5	0.40	0	0	0	0	Dead	Dead	SM	Dead, crown removed to leave habitat pole at 4.5m. Within falling distance of residential fence line West. Subject to Tree Preservation Order: EH983.	Re-inspect within 24 months to assess structural condition.
Т5	<i>Fagus sylvatica</i> (Beech)	4	0.08	0.5	0.5	0.5	0.5	Good	Good	Y	Recently planted, stakes and ties still attached. No significant features.	None

Picture of T3 showing crown removed to leave habitat pole at 7m.

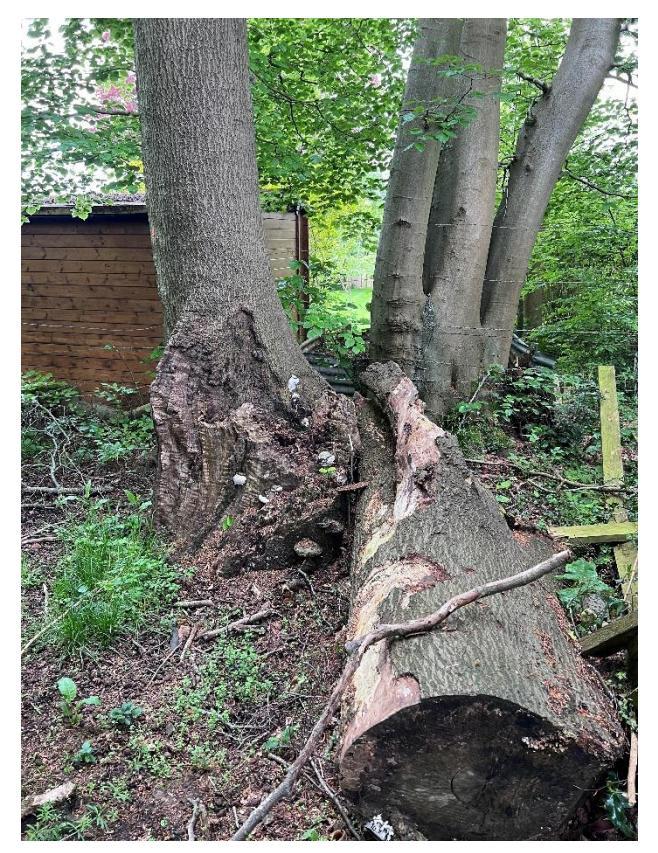
Picture of T8 showing multiple *Ganoderma applanatum* fruiting bodies on failed decayed stem.

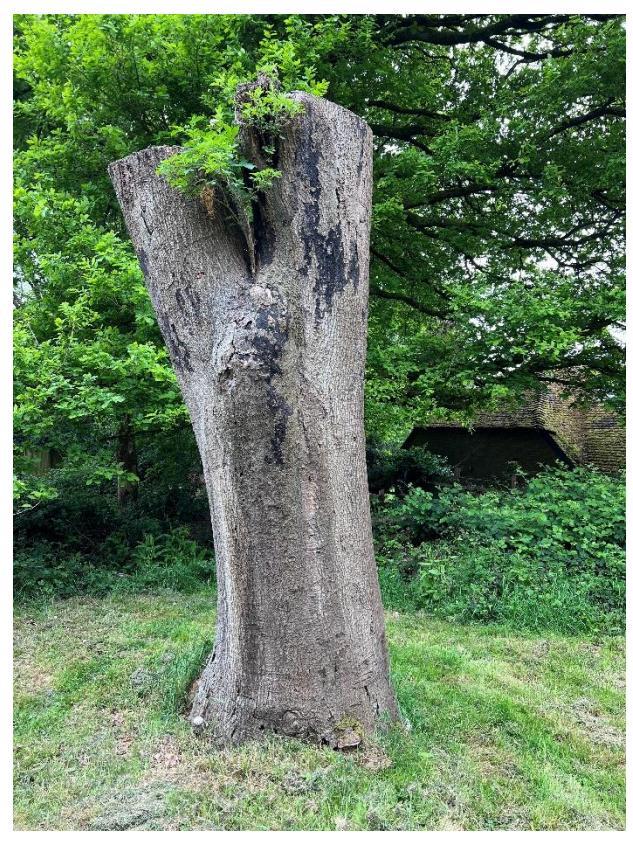
Picture of T12 showing crown removed to leave habitat pole at 3m.

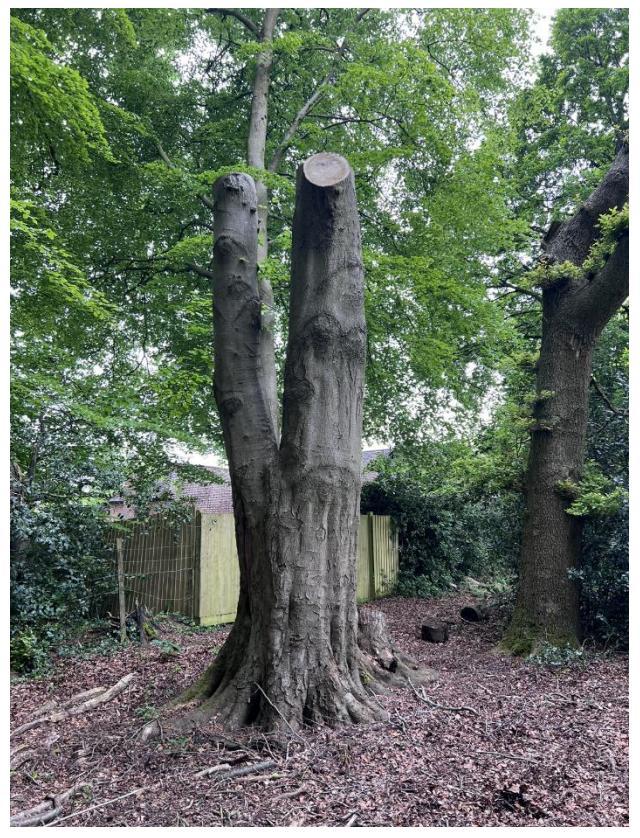
T10	<i>Fagus sylvatica</i> (Beech)	5	1.00	1	0	0	1	Poor	Poor	Μ	Crown removed to leave habitat pole at 5m. Singular functioning branch to the North-West. Twin stem from ground level. Stem to the North has failed historically and been removed. Partly occluded wounds on stem, within falling distance of residential fence line West. Subject to Tree Preservation Order: EH983.	Re-inspect within 24 months to assess structural condition.

Picture of T10 showing crown removed to leave habitat pole at 5m.

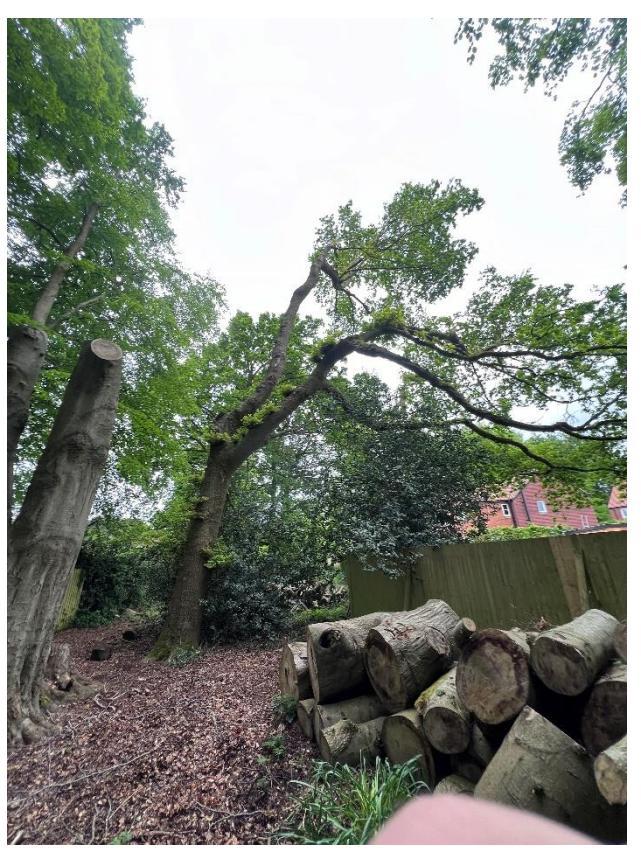
ID	Species	Heig ht	Trun k	Bran	ich Spr	ead	(m)	Physiological Condition	Structural Condition	Life Stage	General observations	Preliminary Management
		(m)	dia. (m)	Ν	Е	S	W					Recommendations
T11	<i>Quercus robur</i> (Pedunculate oak)	20	0.70	9	11 #	1	0.5	Good	Poor	М	Asymmetric crown, historically suppressed by T10 crown bias to the East over residential garden. Multiple historic failure points with decayed stubs.	Crown reduction by 2- 3m to the East and 2m in height, to significantly help reduce load.
											Multiple partly and fully occluded wounds on stem. Minor deadwood. Significant extension of lower limbs to the East with minimal adaptive growth present. Subject to Tree Preservation	Re-inspect within 24 months to assess structural condition.
											Order: EH983.	
T12	Fagus sylvatica (Beech) Sambucus nigra (Elder)	3	0.95	0	0	0	0	Dead	Dead	М	Dead, crown removed to leave habitat pole at 3m. Multiple fungal fruiting bodies at base North, East and West in similar appearance to <i>Ganoderma applanatum.</i> Elder sapling growing from decayed union at 2m. Subject to Tree Preservation Order: EH983.	None

Picture of T11 showing asymmetric crown from suppression and bias growth pattern to the East over residential garden.

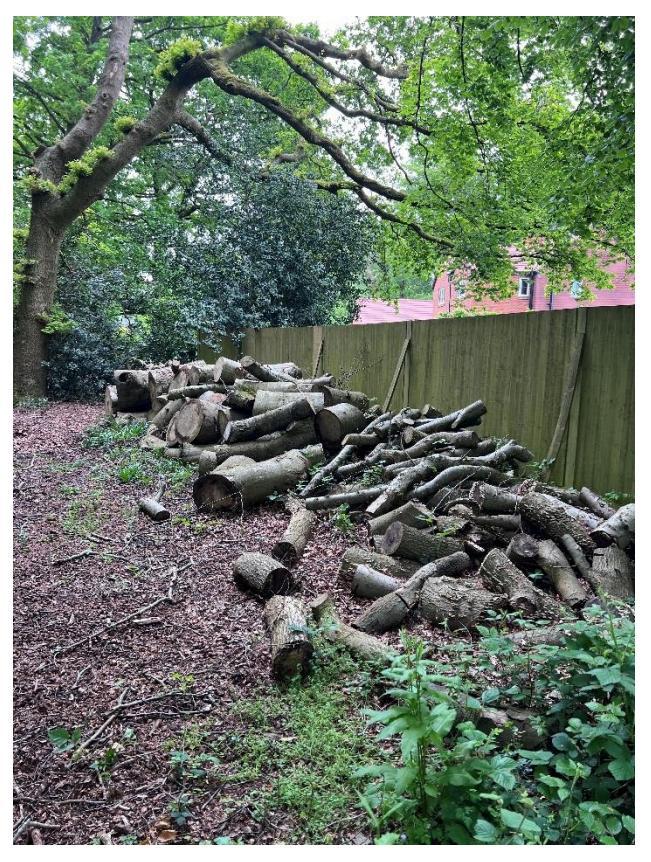
(m)	dia. (m)	N								Recommendations
G7	Fagus sylvatica (Beech) x5 Quercus robur (Pedunculate oak) x4 Crataegus monogyna (Hawthorn) Ilex aquifolium (Holly)	25m Max	1.15 Max	As s	shown Works	on Tr Plan	ree	Fair	Fair	Y-M	Mature Beech and Oak trees with Holly and Hawthorn undergrowth. History of tree removal leaves remaining trees exposed. Logs, woodchip and brash piles within group. Multiple pruning wounds. Multiple fully and partly occluded wounds. Supressed growth patterns due to adjacent trees. Bark inclusions with minor exudation. Minor to moderate deadwood with a low target. Subject to Tree Preservation Order: EH983.	Re-inspect within 24 months to assess general condition.
Т8	Fagus sylvatica (Beech)	5	0.70	0	0	0	0	Dead	Dead	М	Tag – 3486. Dead, crown removed to leave habitat pole at 5m. Twin stem from 0.5m. Within falling distance of residential fence line. Multiple <i>Ganoderma applanatum</i> fruiting bodies on failed decayed stem. Subject to Tree Preservation Order: EH983.	Re-inspect within 24 months to assess structural condition.

Picture of G7 showing logs, woodchip and brash piles within group.

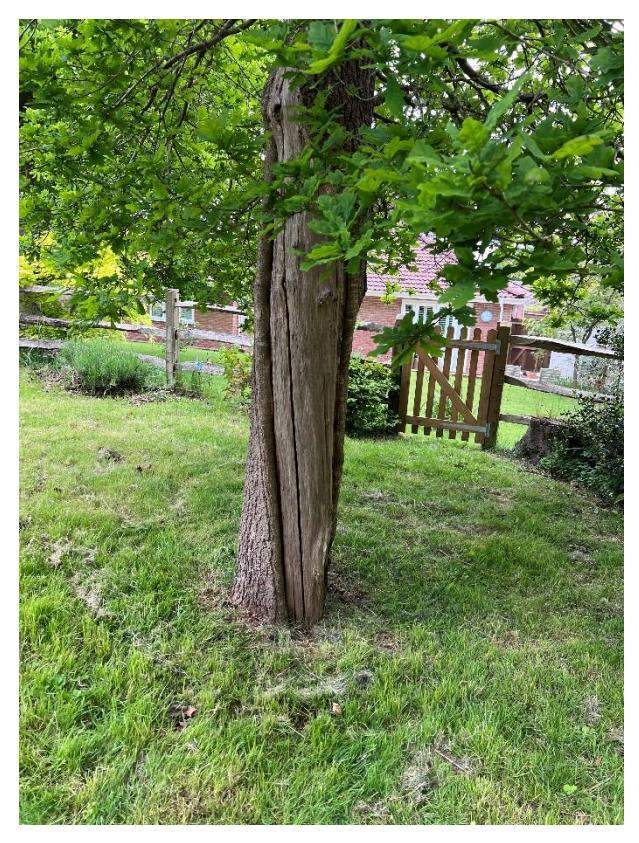
Picture of T14 showing significant stem wound spirals from ground level to 5m.

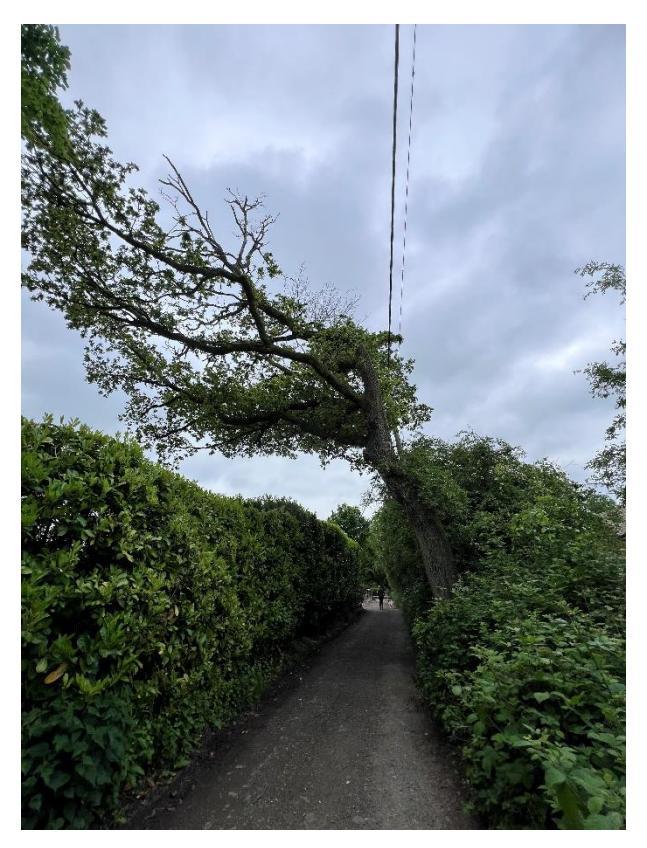
Picture of T35 showing asymmetrical crown bias to the South, and power and telephone cables within crown.

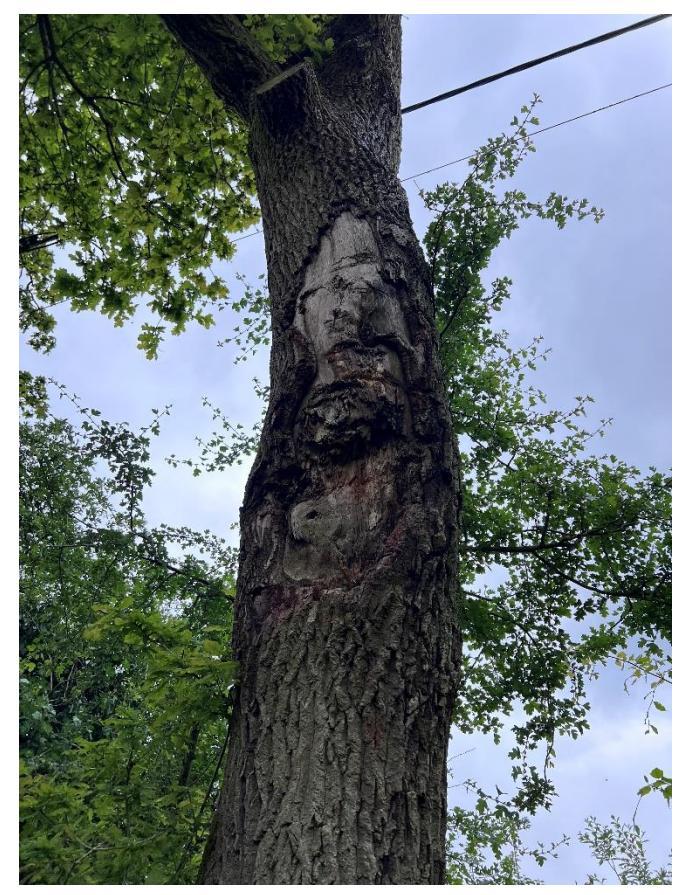
Picture of T35 showing major stem wound and dysfunction at 3m South, and power and telephone cables within crown.
